Manhole Inspection Summary

Manhole # S29II_014MH

Insp Date: **4/10/07 10:00 AM**

Location Address: **240 LAURENS ST**

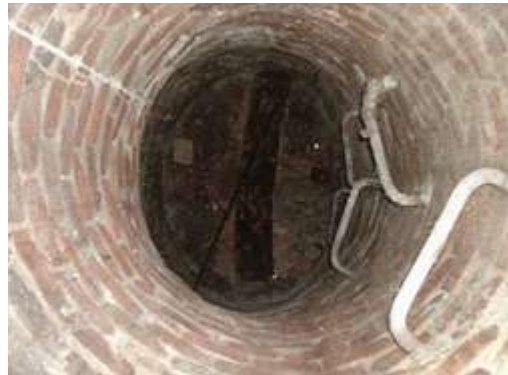
Top View

Corroded steps. Bench and Channel debris.

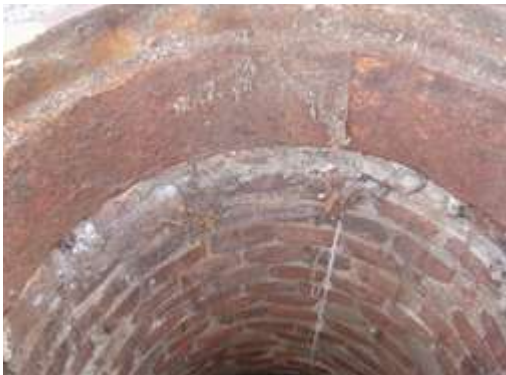
Defect

Adjustment deterioration and infiltration - other side.

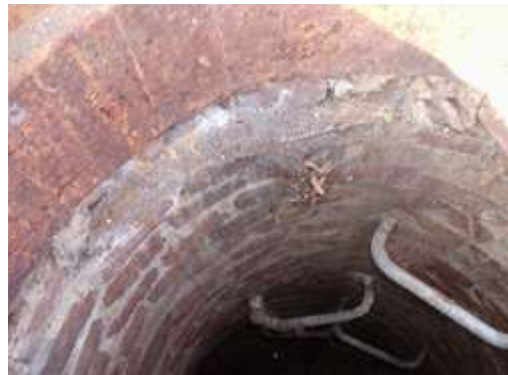
Defect

Condition: ☐ Sound ☐ Cracked ☐ Root Intrusion ☐ Loose Brick ☒ **Deteriorated**

Infiltration: ☐ None ☒ **Joint** ☐ Cracks ☒ **Mortar** ☐ Roots ☐ Wall

Adjustment deterioration and infiltration.

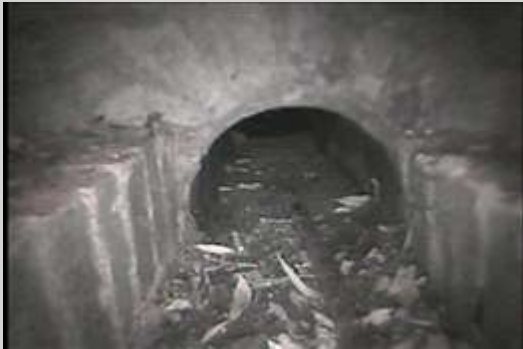
8 in. Circular Gravity Sewer
Pipe Out @ 12 O'Clock

Deposits: ☐ None ☒ **Mud** ☐ Sludge ☒ **Debris** ☐ Grease

Silt Depth: **2** (in.) Deposits Extent: **Medium**

Infiltration: **Evidence** Pipe Seal Cond: **Unknown**

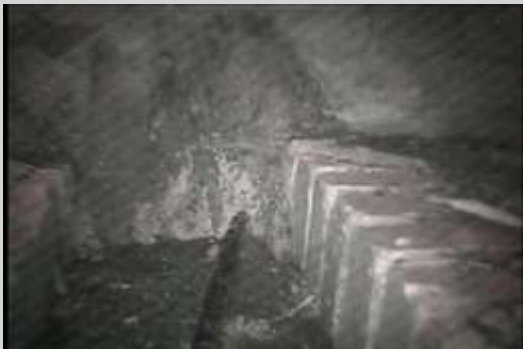
Pipe In @ 6 O'Clock

Connects To: **Stub connection / abandoned**
